LAKE GLORiette DAM AND DIKE  
NH 00171 & 00168

PHASE I INSPECTION REPORT  
NATIONAL DAM INSPECTION PROGRAM

AUGUST 1979

Identification No.: NH00171 and NH00168  
Name of Dam: Lake Gloriette Dam and Dike  
Town: Dixville  
County and State: Coos County, New Hampshire  
Lake: Lake Gloriette  
Date of Inspection: June 7, 1979

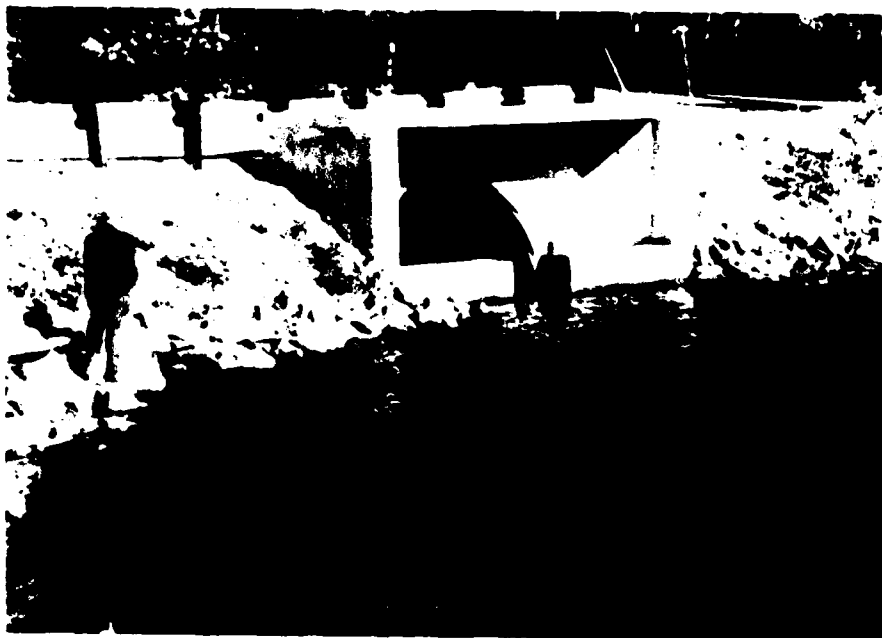
d. Appurtenant Structures. The overflow spillway is located in the center of the dam (south embankment). The concrete spillway is 6.5 feet high and 19 feet long with a 4.0 foot wide wood stoplog section at the center. (See Appendix C - Figure 16.) Overflow discharges into a 7'7" high by 11'10" wide corrugated metal arch pipe which passes through the dam embankment and discharges to the tailwater approximately 22 feet below the crest of the spillway. (Appendix C - Figures 17 & 18.) The overflow structure and outlet pipe were observed to be in excellent condition with no evidence of deterioration or distress. The wooden stops and steel stoplog slots were also observed to be in good condition. However, some surface rust was noted on the steel stoplog slots.

Figure 4 - Upstream face of the spillway.
